AMC COREWELL™ delivers improved core sample recovery

CASE STUDY

AMC COREWELL™ CASE STUDY

Delivers improved core sample recovery in the Northern Cape Iron Fields, South Africa

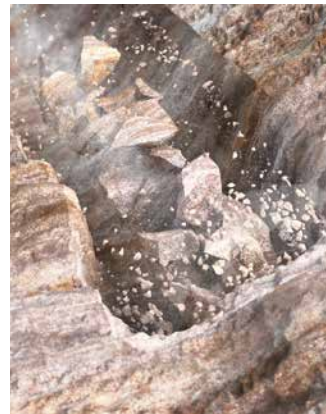
Drilling in unconsolidated and reactive formations can result in poor core recovery.

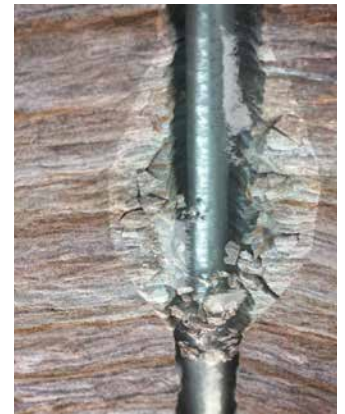
Reactive clay rich formations are susceptible to washouts, the hole wall can become unstable and collapse.

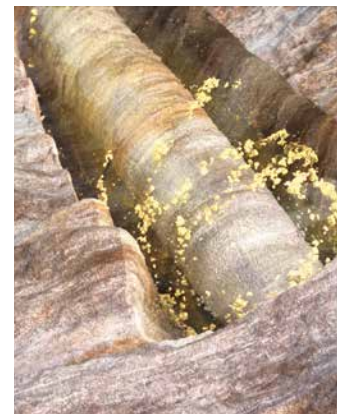
A polymetric network forms a web-like protective barrier, holding the core together as it travels to the surface.

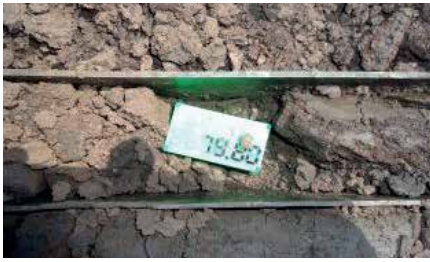
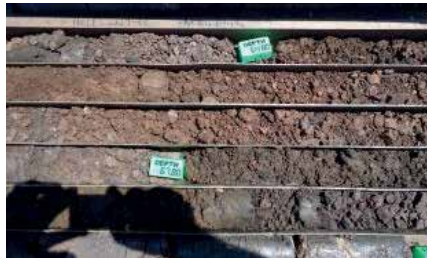
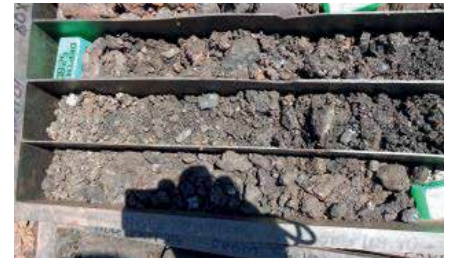
Before AMC COREWELL™

Poor core recovery is visible in the black mudstone.

Drilling companies are contracted to provide the customer uncontaminated quality core at a predetermined rate of recovery (normally 95 – 98% minimum). Looking at previous drilling history, Earth Resources could only achieve a 10 – 50% recovery rate in the clay bearing formation and black mudstone. AMC COREWELL™ provided an immediate improvement maintaining an average recovery rate of 91% over the 40.9m of drilling.

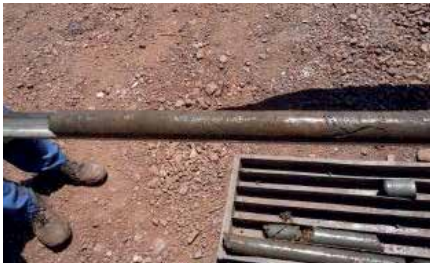
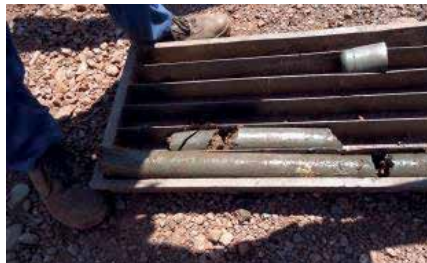
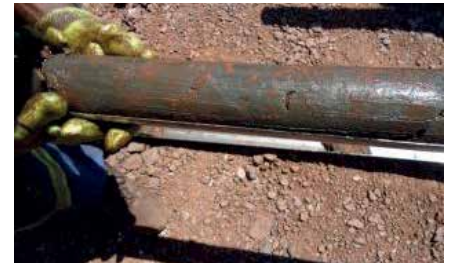
After AMC COREWELL™

Improved core recovery is visible in the black mudstone after introducing AMC COREWELL™.
