# AMC BOS™ recovers an abandoned hole and boosts productivity in Arizona, USA

## CASE STUDY

AMC's Borehole Optimisation Solution™ (AMC BOS™) secured casing, improved fluid returns and advanced an abandoned borehole in Arizona, USA. The solution provided significant financial benefit, addressing issues which the drilling contractor had been facing for over 10 years with conventional grouting methods.

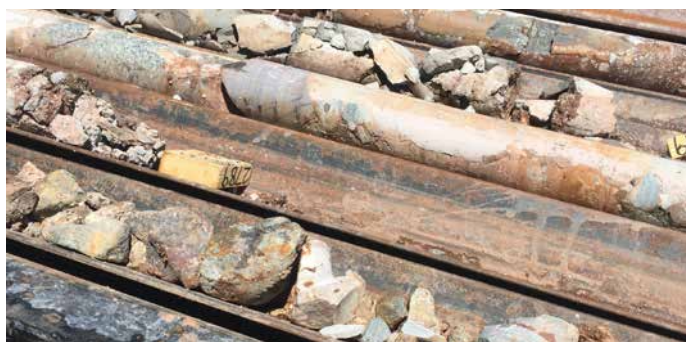
## Before

Formation before deploying the AMC BOS™.

AMC BOS™ was able to stabilise the caving and broken ground, allowing the drill crews to advance the hole a further 93 ft in one shift. The results were visible in the core samples pictured.

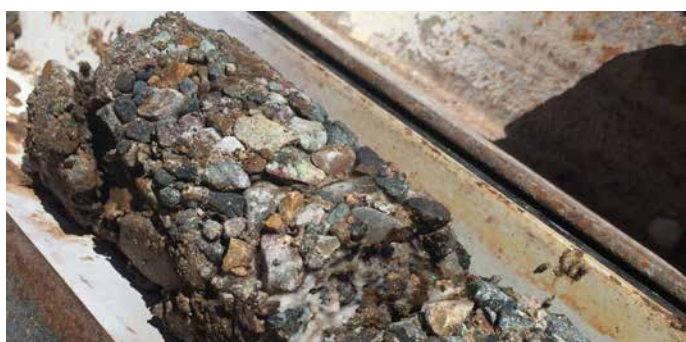
## After

Using the AMC BOS™ consolidated the formation.
