# AMC RESI DRILL™ achieves 100% core recovery and reduces costs

## CASE STUDY

# AMC RESI DRILL™ CASE STUDY

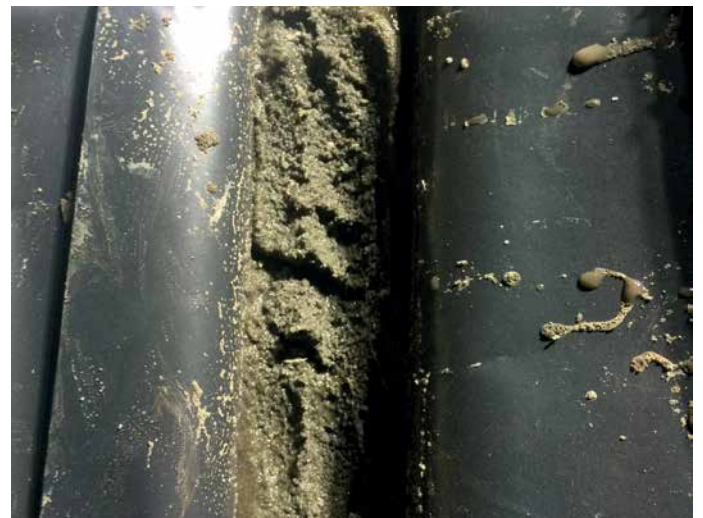
## Before

Core recovery before AMC RESI DRILL™.

The experienced drill crew at the site employed the “dry plugging” drilling technique, which raised core recovery rates up to 83%, dropping to 50% in sandy conditions. Given the nature of the sandy formation, viscosity was kept high, at 70 seconds, to aid recovery, which was producing significant wear and tear on the mud pumps.

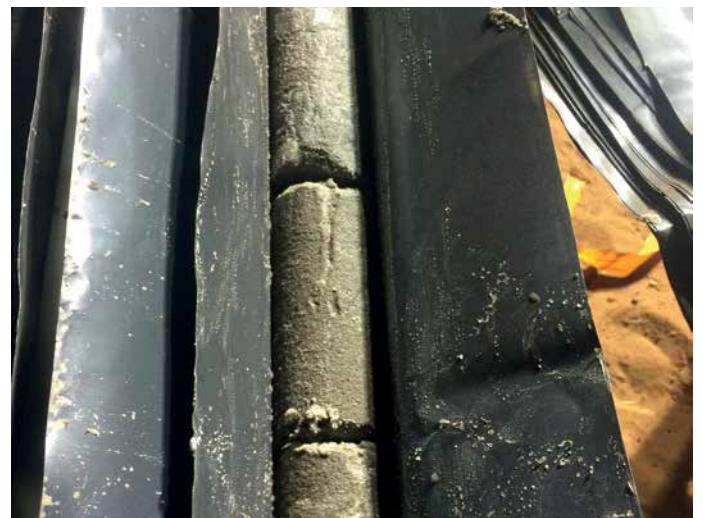
## After

Core recovery after AMC RESI DRILL™.

AMC's technician adjusted the mud system to achieve the optimal coating of the core. Other modifications included adjusting the solids in the system to counter the fresh mud system and increasing the AMC AUS GEL XTRA™ content.

These changes delivered the coating on the core to ensure improved core recovery. The system was now delivering optimal results, including:

- 94% core recovery
- Filtrate control under 10cc's
- Viscosity reduction from 70 seconds to 60 seconds
- Rate of penetration (ROP) increased.

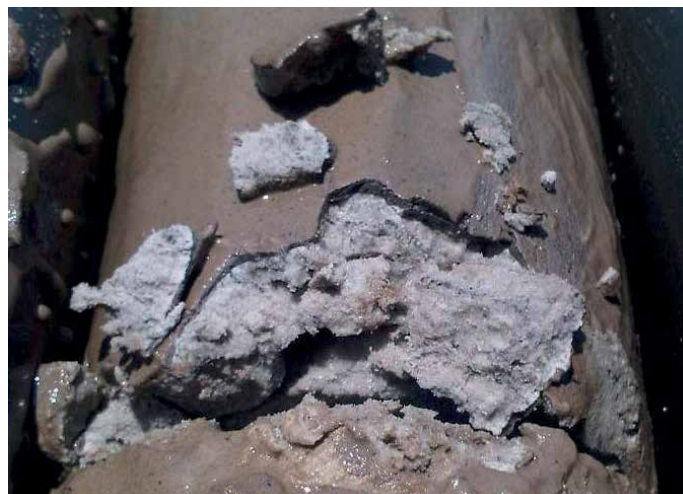
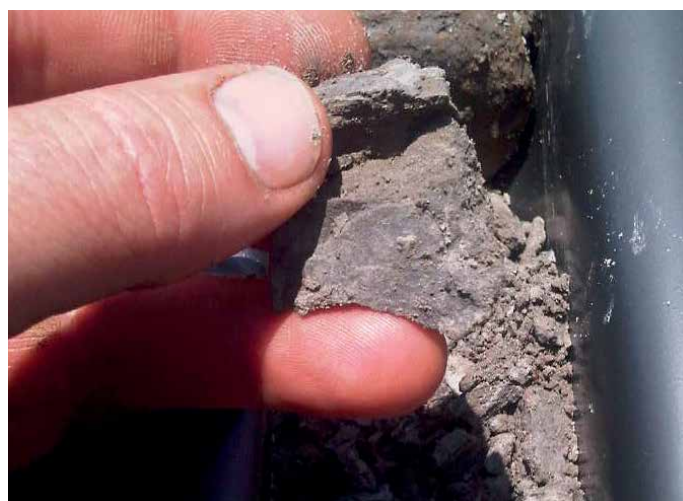
The thick coating created by AMC RESI DRILL™ maintains integrity of core samples in fine to coarse sand formations.

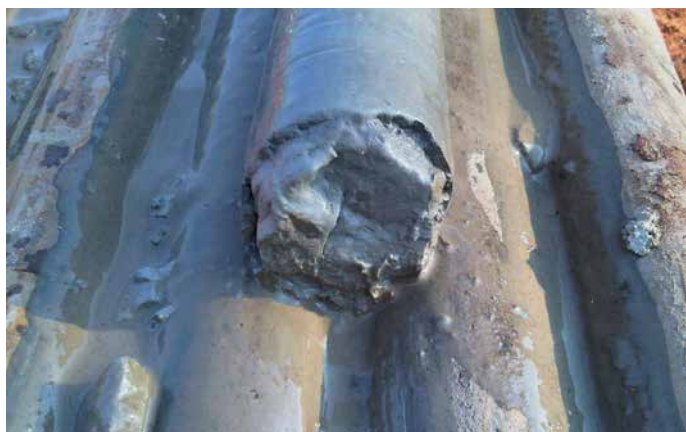
*The thick coating created by AMC RESI DRILL™ maintains integrity of core samples in fine to coarse sand formations.*
